West Wiltshire Society of Model Engineers Newsletter

Issue No. 6 May 2019

Roller Rebuild (Part 3)

'Rebuilding an Aveling and Porter Steam Roller No. 11296 of 1925'

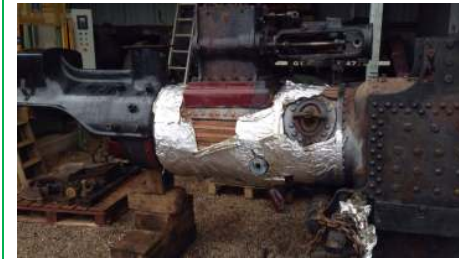
With the "chassis" of the roller now sat in the yard, the last of the components were to come off. The brass bands were unbolted and removed, allowing the painted cladding sheets to be removed and exposing the wooden lagging underneath. The wooden lagging had been wrapped in tin foil, I can only assume the foil was liberated from the kitchen without the significant other knowing about it (fig 1.).

Figure 1 - Cladding sheets removed exposing tin foil wrapped boiler

There was no point in retaining the wooden lagging for reuse so that was pulled off to help with firing another engine having its steam test. The steering scroll was then unbolted along with the cast brackets holding up the steering worm and chains. The headstock (the big ornate casting at the front which is supported by the front rolls) was next to be removed. The headstock is bolted to the smokebox with ten 1 1/2" Whitworth bolts, five on each side arranged in a "star" formation. These were unbolted after a fair amount of effort and the bolts were knocked through into the smokebox with a 20lbs sledgehammer. These took an enormous amount of effort to knock through, with 2 of the bolts shearing which rang some alarm bells- these bolts should not break under

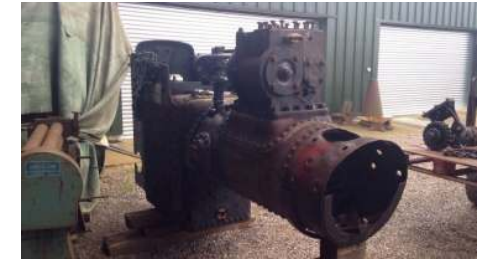
compressive/shock loading. One of the bolts remained stuck in the headstock and had to be burned out with the acetylene torch. Once the bolts were out, the headstock was lifted off the boiler barrel/smokebox with the forklift and a small strop, leaving a bare boiler and cylinder block (fig 2.).

Figure 2 - Bare boiler

With the bare boiler sat out in the yard, we were able to make a quick assessment of the work to be completed. It was apparent when I purchased the roller that a minimum of a new firebox and new front tube plate would be required. The only other obvious thing that would need to be addressed at some point was a patch of weld on the throatplate next to the flange into which the barrel is fixed.

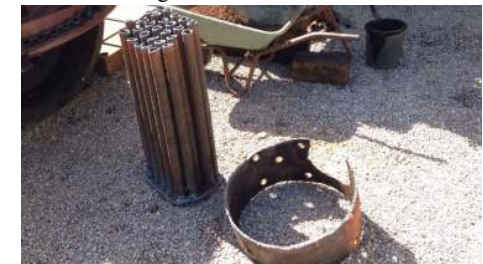
Figure 3 - Smokebox off and tube nest/tubes out

As said above, the tubeplate was scrap and therefore the tubes would be scrap. The easiest way to work on the tube plate is to remove the smokebox, do the work, and then weld on a new rolled smokebox (the original smokebox was too thin to reuse and would be scrapped anyway). Without much deliberation, the acetylene cutting torch was put to work removing the smokebox then cutting down the middle of the tubes, accessed through the large inspection hole in the side of the barrel. With the tubes cut along their section, the tube nest in the front tube plate was

cut out and the tube nest and tubes were pulled out in one go (fig 3.). With the tubeplate and tubes removed, full access was gained to inspect the internal surface of the barrel. Upon initial inspection, the barrel appeared to be in relatively good condition with some pitting along the bottom. One of the interesting things to note at this point was the 4 “screwed” rivets along the lap seam of the barrel (fig 4.). I understand that this is generally railway and marine practice when rivets have failed but are inaccessible from the inside and consequently can’t be replaced and riveted, so a rivet with a threaded shank is screwed into the hole. This didn’t throw up any major queries about the barrel’s suitability and it was assumed that the barrel would be retained.

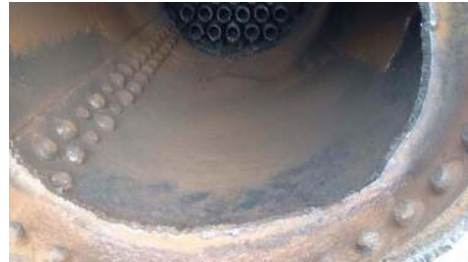
Figure 4 - Boiler barrel seam with 4 “screwed” repair rivets

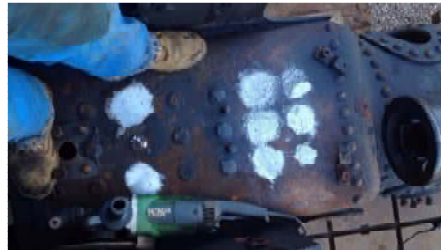
The very first job with firebox removal is to grind down the heads of the stays to be flush with the external surface of the plate. This is a quick and

simple task to achieve- when your stays are a pure and soft steel. But when your stays are a hard grade of steel and welded with a surface area and head volume twice as large as it should be, the time taken to grind these down extends by a considerable amount (fig 5.).

Figure 5 - Half way through grinding the crown stays

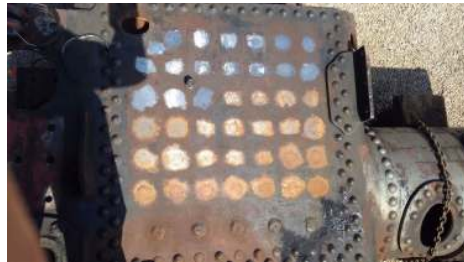
I spent 5 days with a 9” angle grinder removing the heads from the 136 stays and the 52 foundation ring rivet heads- the duration roughly equating to 56 hours of work (fig 6. and fig 7.).

Figure 6 - The last side complete!

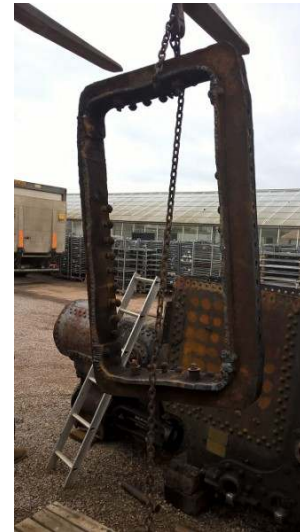
We achieve this by “windowing” the walls of the firebox, removing the plate in between every other column of stays. The cutting torch can then access the stays and cut through them. This technique can’t be employed with the foundation ring, so the pressure of the gas in the cutting torch is used to burn out and blow the rivet material through the rivet holes until clear.

Figure 8 - 1st half liberated!

The foundation ring has to be removed before the firebox and to do this the boiler is turned upside down, then the firebox is separated from the foundation ring by flame cutting all the way around above the ring and using a hydraulic jack and a girder to force out the ring (fig 8.). Once partially free, the ring can be lifted out with the forklift. In order to remove the firebox easily, the tube nest was cut out and pushed into the barrel as the

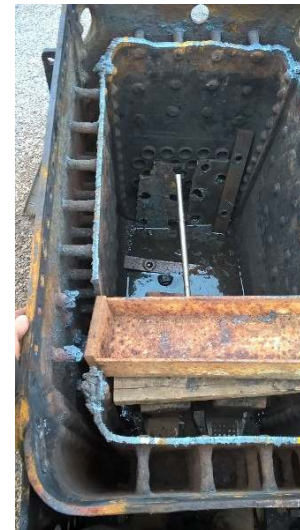
Figure 9 - Jacking bar used to remove the foundation ring. Note the stays haven’t been cut yet.

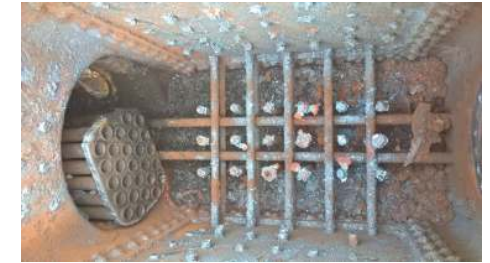
remainder of the tubes wouldn’t clear the plate work. The fire box could then be lifted out with the forklift, exposing the cross stays (fig 9. and fig. 10).

Figure 10 - Box removed showing cross stays. Note the tube nest pushed into barrel to aid box removal
