West Wiltshire Society of Model Engineers Newsletter

Issue No. 8

Roller Rebuild (Part 5)

'Rebuilding an Aveling and Porter Steam Roller No. 11296 of 1925'

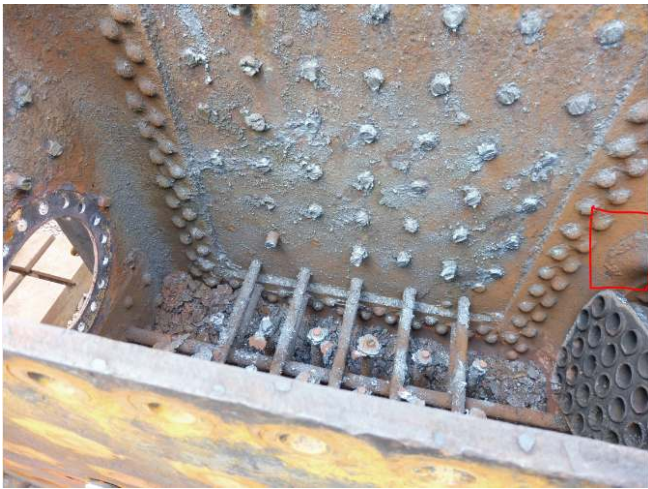
Figure 1 - View showing one of the welds on the throatplate radius shortly after removing the firebox

The reason for this welding is because the radius of the flange, which you can see goes in several directions, has fatigued over time and cracked. Bear in mind that ultimately this flange supports the entire front end of the engine. It's very common for Avelings with the belpaire boiler (flat-topped crown sheets) to crack along these corners. It all comes down to the manufacturing process- these plates would have been pressed over a former from flat sheet steel in one go, but as the red hot metal cools down and contracts, a lot of the stresses get caught in these corners which are being stretched in every direction, hence why they fatigue and crack. I could see when I stripped the engine down that there were some patches of weld on the outside of the throatplate, but I was working on the inside and could see weld- how did that get in there? If you look back to the article where I removed the firebox, I noted that the tube nest had been cut out

at some point and welded back in- well the reason for that was so the repairer could get access to the cracks and weld them up. It was far cheaper for the owner/contractor to do this and keep the engine working than it was to scrap it and buy a new roller to work the job.

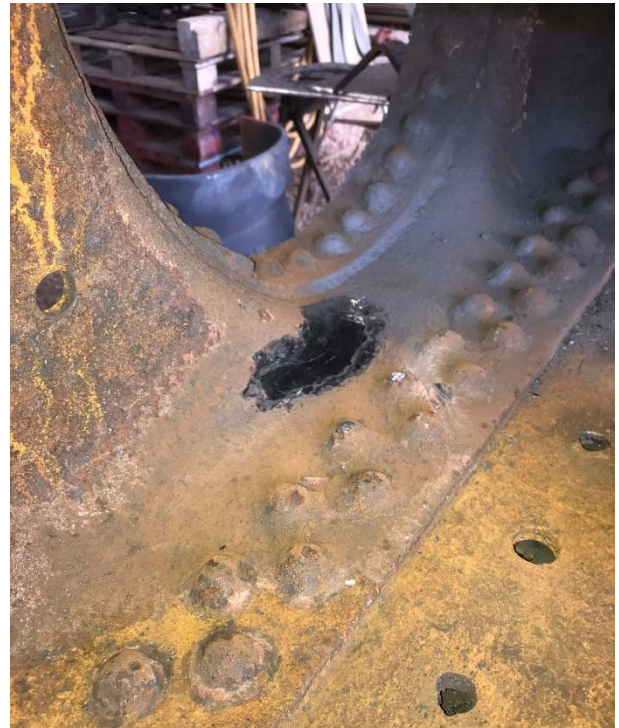
Figure 2 - Grinding away the weld and grooving out/chasing the cracks

These working-day repairs aren't suitable by modern standards and certainly wouldn't pass a boiler inspection, so I had to remove the weld internally and externally then groove out and chase the crack until it stopped and met fresh metal again (**fig 2.**). I ended up almost grinding through the thickness of the plate to remove all of the crack, then filled the groove with a good weld (**fig 3. and 4.**).

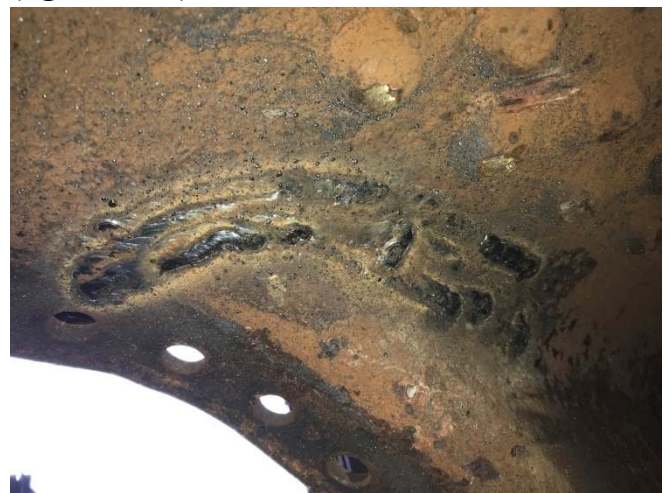
Figure 3 - Welding up the crack internally

The work of course had to be checked by the boiler inspector who carried out an NDT (Non-Destructive Test). Basically he sprayed a penetrant dye over the welds and checked there was no evidence of the cracks showing.

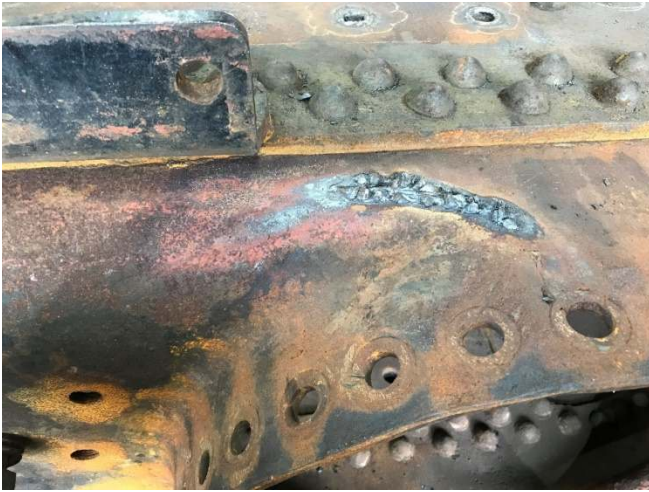
Figure 4 - Welding up the crack externally

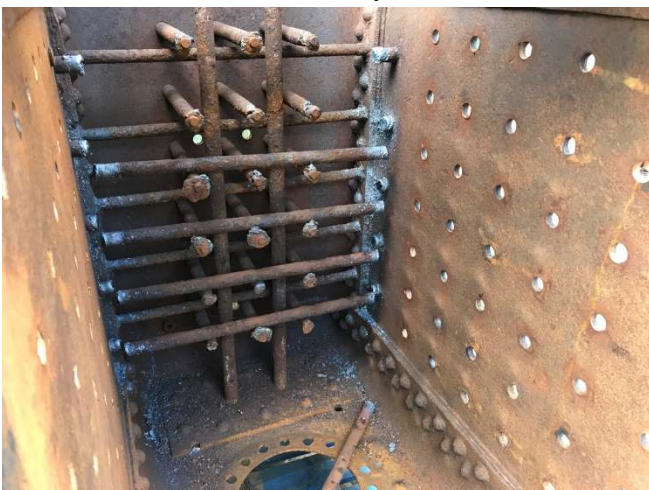
Figure 5 - Cutting out the cross stays with the cutting torch

There's no point in avoiding it, so I set about cutting out the old stays with the cutting torch from inside the boiler (**fig 5.**). There are 2 rows of 5 stays, the bottom row having had the same treatment as the firebox stays where they had been removed, had 1" bar pushed through and then seal-welded. The top row of cross stays were original screwed-type stays with a 1" BSW thread.

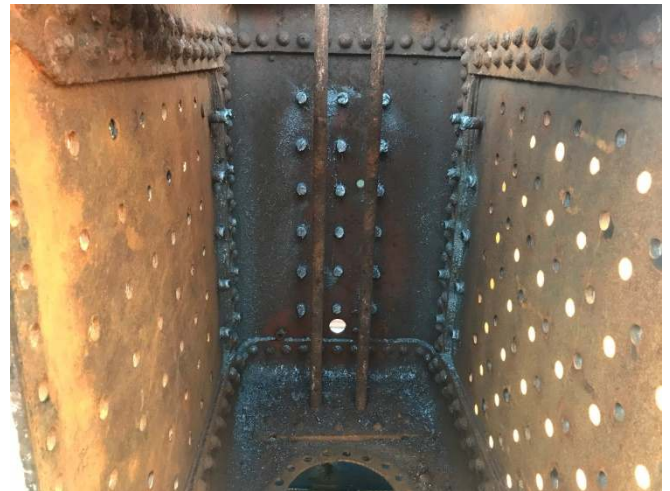
Figure 6 - Crown stays removed

Once I had cut out the cross stays I could also cut out the crown stays (**fig 6.**). In a way it's good that I had to remove the cross stays because with the cross stays still in place I couldn't drill out the crown stays from the inside but would have to drill them from the outside. Much the same as the firebox stays, the crown stays had been welded and left no evidence as to where the centre point of the stay would be. I had initially measured the centres of the crown stays from the inside and translated it on the outside and centre punched the centres. It's a good job I never drilled to those marks because I found they were a long way out once I had pilot drilled from the inside (**fig 7.**).

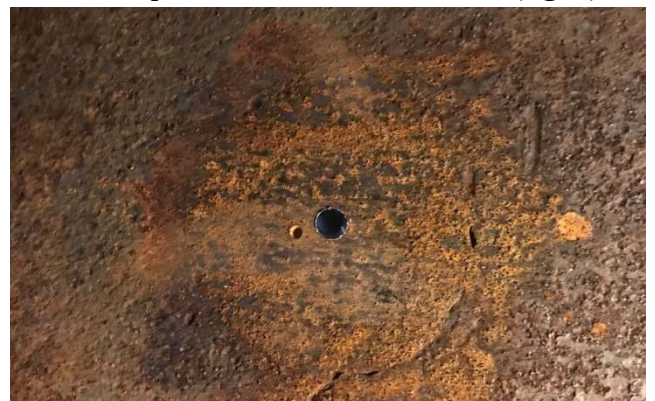
Figure 7 - External view of the crown sheet showing the measured stay centre and the piloted centre

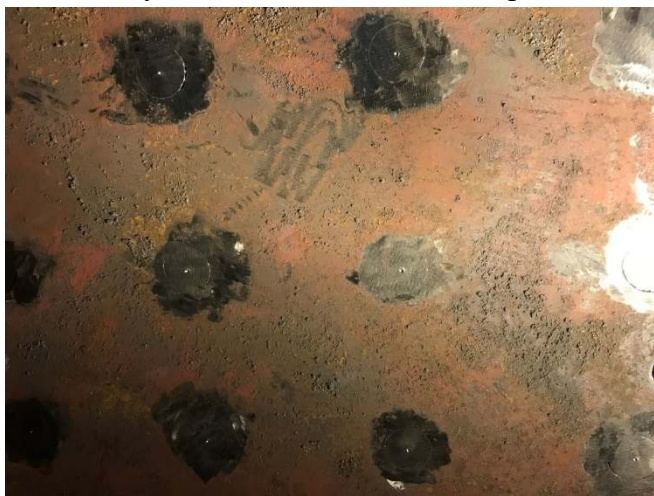
Figure 8 - Crown stays centre punched from inside the boiler

With the longitudinal stays removed, I could then grind down the stubs of the crown stays flush to the plate then centre punch and pilot drill with the mag drill. This sounds like a 5 minute job but it wasn't quite as simple as that. The boiler was resting on its side so I could climb in through the hole left by the firebox and lie on the inside of the hornplate. While lying down I had to accurately swing the hammer and centre punch the stays (**fig 8.**). Then the fun bit, holding the mag drill up against the plate in the right place while trying to activate the electromagnetic base, and of course actually drilling the hole. At least I only had to do the pilot drilling from the inside as I could put the tapping drill through from the outside with the boiler stood upright (much less heavy lifting in a confined space!) (**fig 9.**).

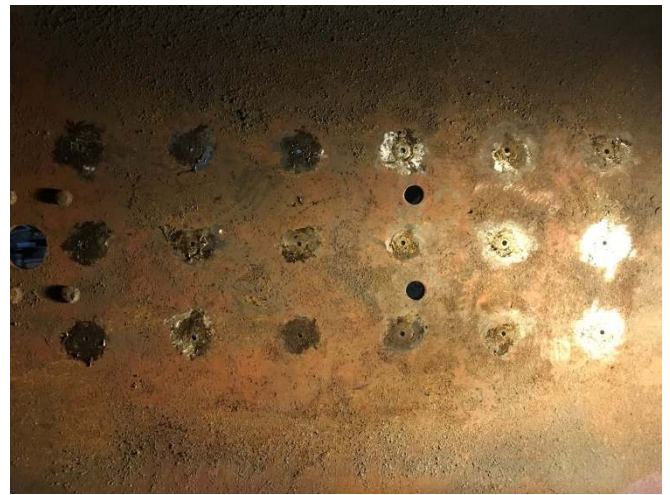
Figure 9 - Crown stays all pilot drilled from inside the boiler

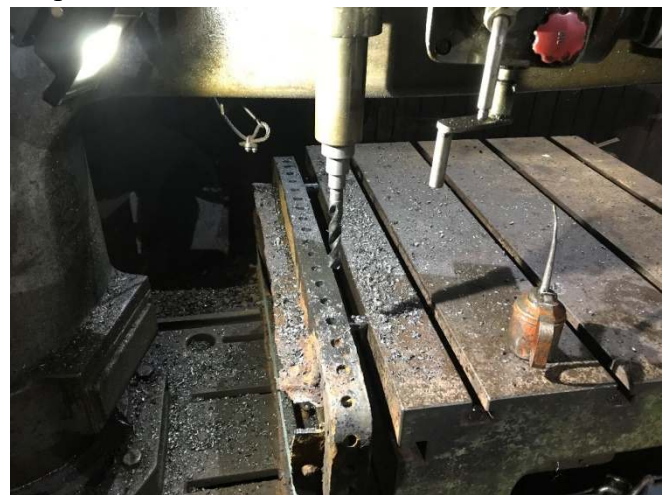
Figure 10 - Drilling out the old rivets from the foundation ring

While the foundation ring had suffered some pitting during its lifetime, it was still in good enough condition to be reused. The first job was to drill out the old rivets and remove the bits of old firebox that were still attached. Thankfully there's a big radial drill at the yard, so I set up a mounting block on the bed of the drill and strapped the foundation ring to the side of it. There's not many occasions in heavy engineering where a pilot drill is used and this was certainly no

excuse- straight through with the clearing drill and plenty of oil then opened up into fresh metal with a reamer (**fig 10.**).

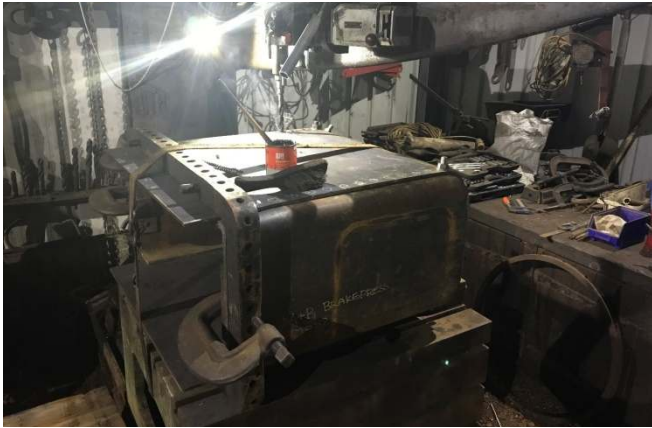
Figure 11 - 3-piece firebox assembly, drilling the rivet holes using the radial drill

The next key stage of the rebuild- the firebox. The firebox in this engine is made up of 3 pieces: two flanged end plates (the rear plate with the fire hole and the front plate with the tube nest) and a one piece crown sheet and walls. When the kit of parts arrived back from the pressing company, I got on and loosely assembled the firebox in the foundation ring- this sets the distance between the two end plates and between the firebox walls. Once assembled, I could copy the rivet spacing from the old firebox and translate it directly onto the new plates using some careful measuring. I marked the hole centres and gave each one a deep centre punch. With all the holes marked out, I could start drilling the rivet holes (**fig 11.**). I drilled then bolted every other hole to make sure the plates didn't move as I worked along the seam. You will notice that the rivet holes on the top of the firebox crown are countersunk (**fig 12.**).

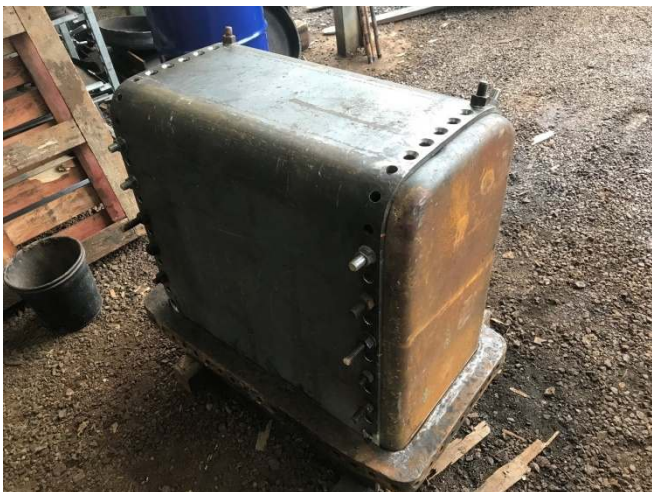
Figure 12 - The drilled and bolted firebox assembly, note the countersunk holes on the crown sheet

These rivets will be made with flat heads rather than the typical domed head as there is a lot of water turbulence across the top of the firebox when hot, which causes increased levels of corrosion around the stays and the rivet heads. So if I put flat heads in, there is less visible material which would otherwise be susceptible to corrosion but still retains the same level of strength.

Once all the holes had been drilled and bolted, I had to ream the holes out to the clearance size for the rivets then deburr all of the holes with a countersink tool in a handheld air drill (industrial size of course!). Now that all the rivet prep had been done, including trimming all the rivets to length, I could start to think about firing them in.

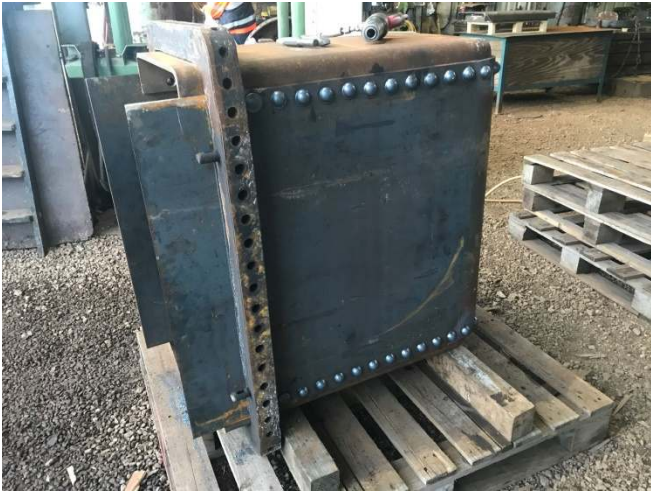
Figure 13 - The riveted firebox assembly

The sequence for hot riveting starts with heating the rivets until they are a bright orange, almost on the verge of burning away. A good tell to know when the rivets are hot enough is when you can see the rivet starting to sparkle. When the rivet is hot enough, they are carried using a pair of tongs by the head and run over to the workpiece and inserted into the hole from the inside (manufactured head on the inside with the shank pointing outwards). We use a piece of equipment called a jam-back to hold the rivet securely in the hole; the jam-back is basically a pneumatic ram which pushes between the rivet and the opposing plate work, keeping the rivet tightly in the hole. Once the call has been given to say that the jam-back has been fitted, a pneumatic rivet gun is used to form the head on the outside. It's key to use all of your weight to really force the gun onto the rivet and stop the gun from bouncing off. It's also important to keep the gun in line with the shank of the rivet in order to form perfect domed heads. In either case, if you don't keep the pressure on the gun or keep the gun straight, you end up splatting the shank of the rivet out the side of the snap and forming a bit of a tumour on the side of the rivet head. Another important note when hot riveting is to minimise the time between removing the rivet from the heat and forming head by as much as possible to prevent the rivet from cooling down too much. If the rivet cools down too much before forming the head, it'll be physically more difficult to form the head which in turn can

In total the firebox is held together with 60 rivets, all of which took only an hour to have riveted together (**fig 13.**). It takes about 10 to 15 seconds to take the rivet from the heat and have the head formed. I do have a short clip showing the set-up which can be viewed on request to anybody interested.

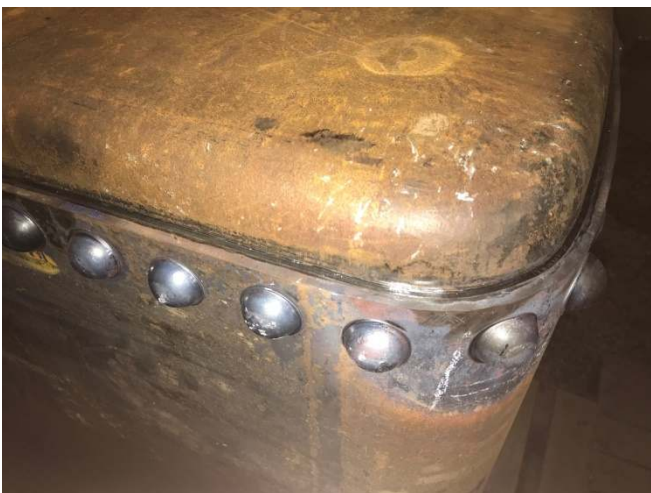
Figure 14 - The caulked joint, achieved with a chisel and a small pneumatic gun

The final stage but possibly the most important stage of the firebox build was to caulk the seams to make them water/steam tight. Caulking in the steam world is using a chisel to force metal into the gap between two plates. The chisels fit into a small pneumatic hammer/gun (basically a small rivet gun) and you simply run the chisel up and down the seam continuously until you get no more gaps in the seam (**fig 14.**). By spending plenty of time and taking plenty of care with the job at this

stage, you help yourself in the long run by making sure the boiler doesn't leak once assembled and hot.
